**Title: Rudder bar and pedals**

Classification: ESSENTIAL / ~~RECOMMENDED~~ / ~~INFORMATION~~  
**Essential** - compliance before next flight

**All EuroFox aircraft**
**Description of defect, implications:**

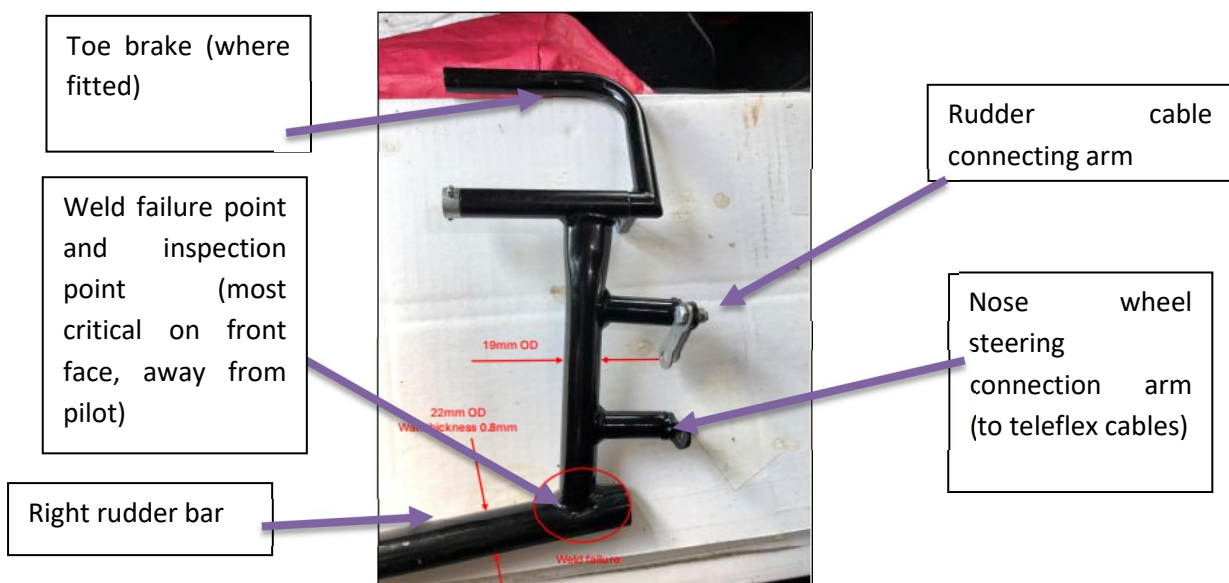
Two very high hour/cycle (1,800 hours and 11,500 cycles) LAA amateur built EuroFOX 914 nose wheel glider tugs had a breakage of the P2 right rudder pedal at the lower right-side weld joint. One of these operators reported that the first sign of a crack in this weld occurred around 400 hours before complete failure. Therefore an immediate quick failure of this weld is unlikely. Three additional tug aircraft, all 5 of which are LAA home built examples have been affected.

High torsion loads are transferred from the P1 right rudder pedal, along the rudder bar, and then through this weld to the P2 right rudder pedal upright. The loads on this weld (shown below) result from general rudder, steering mechanism, and toe brake use, particularly on the ground.

View of the P2 position right hand pedal assembly (nose wheel)

**Before next flight:** inspection by a *'Qualified Person'* of both rudder pedal to rudder bar welds on both right and left rudder pedal assemblies.

**Ongoing, every 10 flight hours:** inspection by a *'Qualified Person'* of both rudder pedal to rudder bar welds on both right and left rudder pedal assemblies.

If any cracks are found, the affected rudder pedal assembly must be replaced **before further flight**.

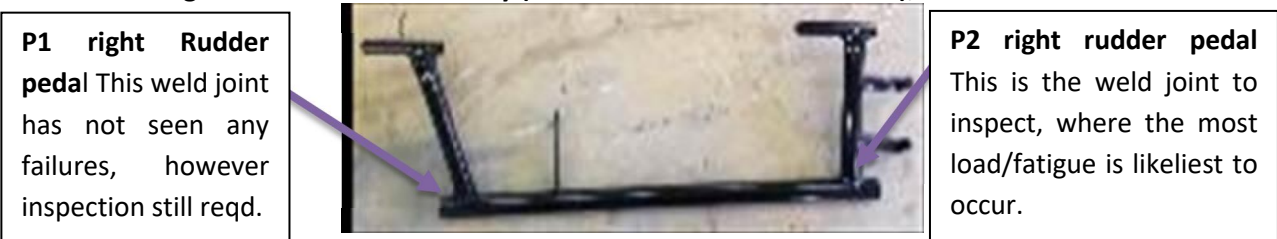
The right weld on the right rudder pedal assembly is the one which has instigated this SB. However, both rudder pedal to rudder bar welds on both pedal assemblies must be inspected.

**Right Rudder Pedal assembly (suitable for nose or tail wheel ), toe brakes not shown.**

Using a mirror and light source as necessary, inspect the welds joining the rudder pedals to the horizontal torque tubes for any signs of cracking, deformation, flexibility or any other anomaly. Particular care should be paid when inspecting the front side of the welds (nearest the firewall).
